Eric's Heritage tips of the month

Tip #2: Paint stripping previously varnished wood

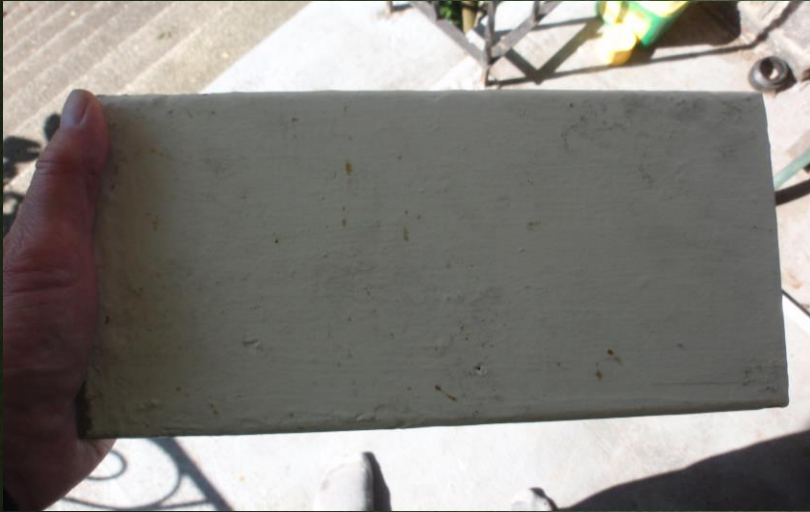
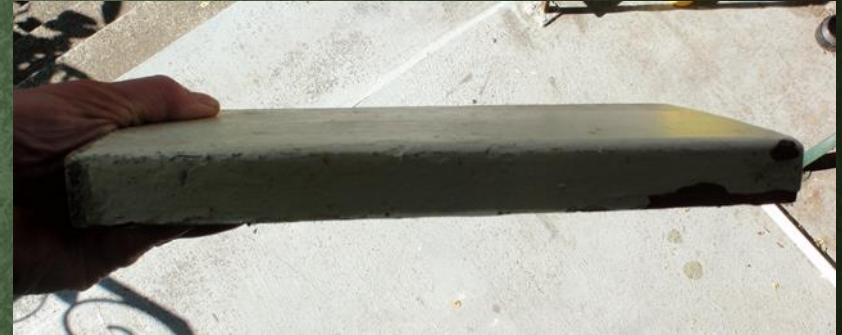
- The pictures show a fully painted plinth with multiple coats of paint
- Paint has chipped to a varnished base coat on the edges
- Paint likely contains lead – assume all un-tested old-house paint contains lead

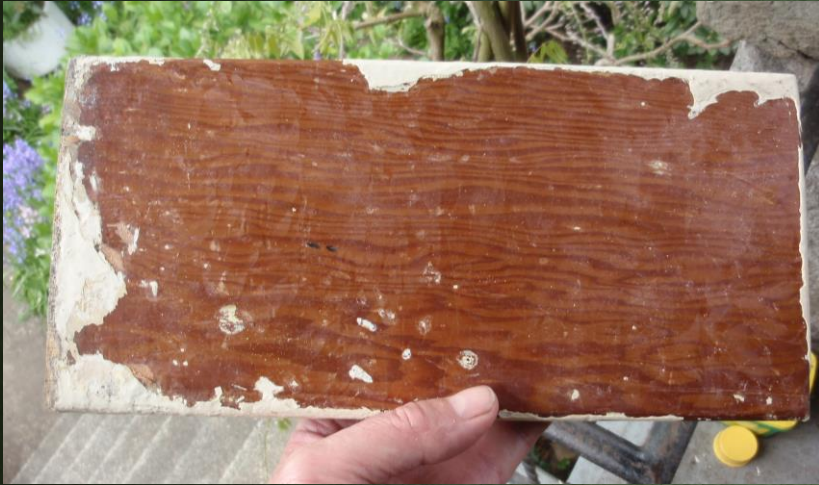
- Strip the principle areas with a single edge razor blade held at a shallow angle
- Scrape remaining paint with a draw scraper (gently, please!)
- Pick off residual paint with dental pics
- Colour deeply embedded paint with furniture touch-up pens
- Re-varnish

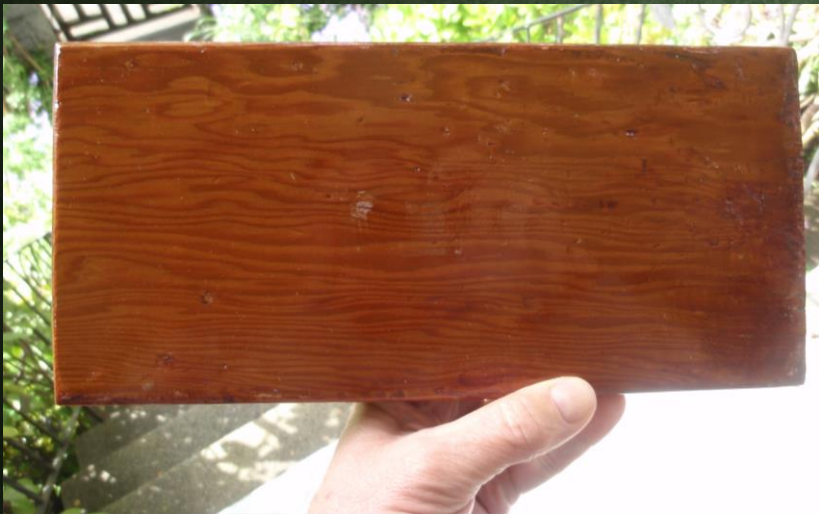
- Strip outside over a tarp
- Wear a lead-rated respirator and gloves
- Use a HEPA shop-vac for final cleanup
